# **TMS320C6748 Fixed/Floating-Point DSP Silicon Revisions 2.1, 2.0, 1.1 and 1.0**

## **Silicon Errata**

Literature Number: SPRZ303F  
June 2009–Revised April 2012

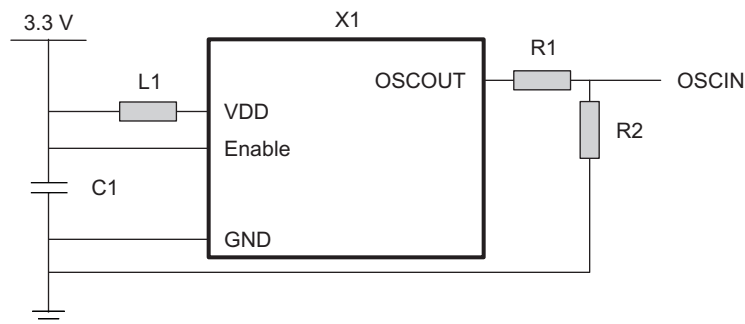
**Figure 2. External 3.3V Clock Source**

On all silicon revisions, certain design elements make this device susceptible to radiated noise during an ESD strike, as described in the standard IEC 61000-4-2. Exposure to the electrical noise caused by the ESD can cause soft device failures due to noise coupling on the system clock (OSCIN). ESD events within the IEC spec range do not cause permanent device damage and full functionality is recoverable with a device reset. The sensitivity to this noise issue is primarily due to the 1.2V oscillator/clock input implemented on this device. The low voltage range, coupled with slow rise and fall times, provides a lower noise margin than other TI devices with higher voltage internal oscillators (e.g. 1.8V or 3.3V oscillators).

If ESD robustness is a concern, it is strongly recommended to avoid using the internal oscillator as a clock source. An external 3.3V clock source with a resistor voltage divider as in [Figure 2](#) can be used to externally generate the required 1.2V input clock. By using an external clock input with fast rise/fall times (less than 5 ns), the noise margin improves significantly, increasing ESD noise resistance.

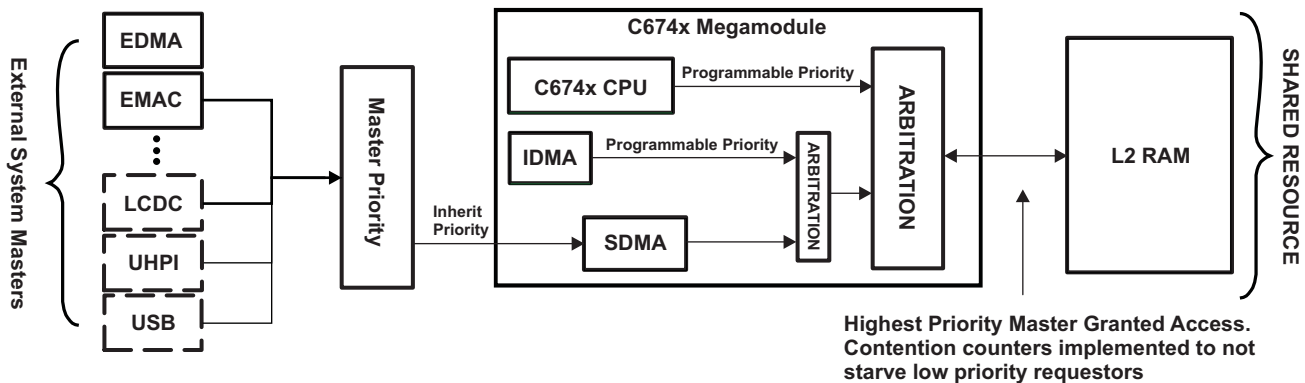
**Figure 3. Priority Arbitration Scheme for L2 RAM**

The C674x Megamodule uses a bandwidth management (BWM) system to arbitrate between DMA and CPU requests issued to L2 RAM. See TMS320C674x DSP Megamodule Reference Guide, Literature Number - [SPRUFG5](#) for more information on the BWM. BWM arbitration grants L2 bandwidth based on programmable priorities and contention- cycle-counters. The contention-cycle-counters count the number of cycles for which the associated L2 requests are blocked by higher priority requests. When the contention-cycle-counter reaches a programmed threshold (MAXWAIT), the associated L2 request is granted a slice of L2 bandwidth. This prevents indefinite blocking of low priority requests when faced with the continuous presence of higher priority requests.

Ideally, the BWM arbitration will grant equal L2 bandwidth between equal priority DMA and CPU requests. Instead, when equal priority DMA and CPU requests arrive at the BWM, bandwidth is always granted in favor of the CPU over DMA. In the case of successive CPU requests, it is possible for the CPU to block all DMA requests until CPU traffic subsides. Additionally, some command logic in the BWM uses priority level 7, which can also result in SDMA stalls when the CPU is also programmed to priority level 7. [Figure 3](#) shows a high level diagram of the arbitration scheme used for L2 RAM requests.

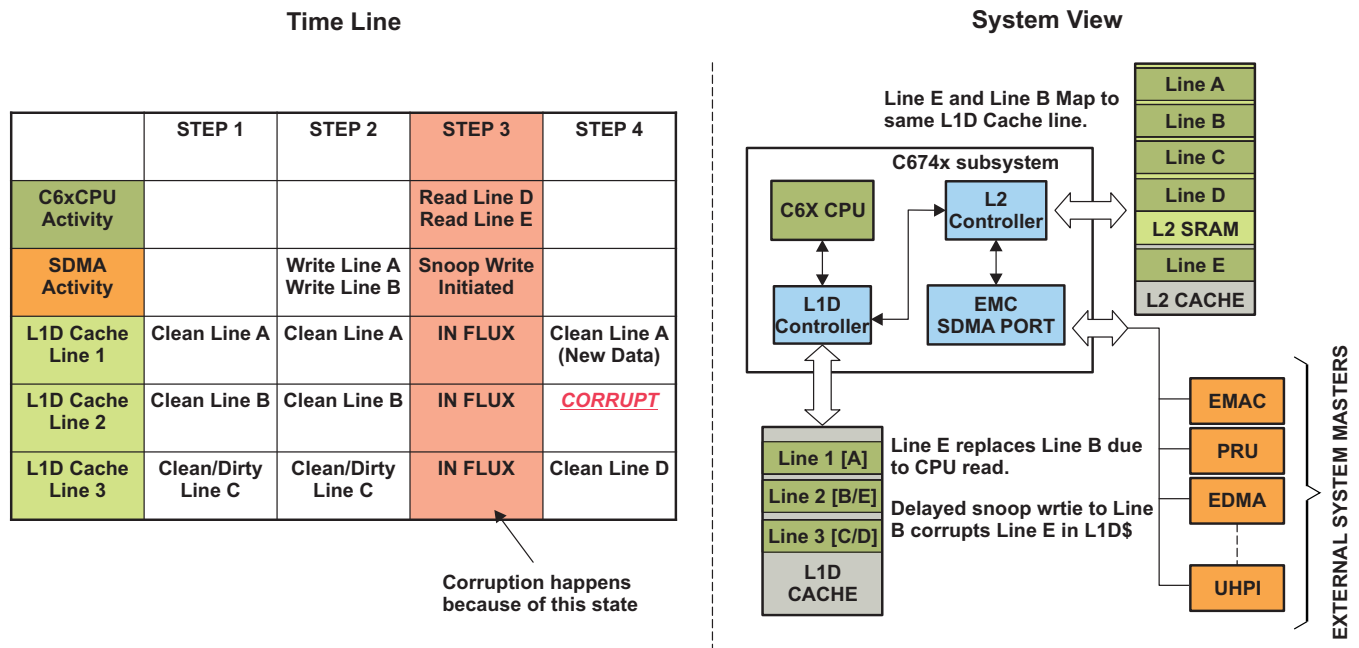
**Figure 4. Example of L1D Cache Corruption**

An L1D cache-line corruption event occurs when all of the conditions in the following steps are met (see [Figure 4](#)):

- Line E in L2 cache is read as a cache hit. Line E is destined to replace Line 2 in L1D Cache, which also has a snoop write pending for the updated Line B content.

- Line D in L2 SRAM is read. Line D will replace Line 3 in L1D cache.
4. When the snoop write operation completes, Line 2 in L1D cache now contains the updated L2 SRAM Line B data instead of the L2 cache Line E data.

The correct behavior would have been to kill the pending snoop write initiated to update L1D cache Line 2 with the updated L2 SRAM Line B data in Step 3. The L1D cache should have evicted Line B and replaced it with Line E data. Instead, the snoop write operation continues and does not complete until after the L1D cache Line 2 has already been replaced with L2 cache Line E data. The snoop write instruction overwrites the L1D cache Line 2 (containing L2 cache Line E data) with the updated L2 SRAM Line B data.

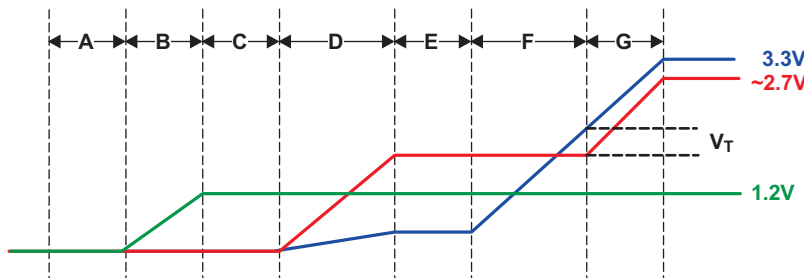
**Figure 6. Faulty power-supply ramp**

The behavior is the same until zone G. When the DVDD3318\_x supply exceeds DVDD18 by a transistor V<sub>T</sub>, the DVDD18 supply begins to be pulled up by the DVDD3318\_x supply and follows the DVDD3318\_x supply by DVDD3318\_x - V<sub>T</sub>. Since the DVDD18 supply is often connected to other 1.8V supplies in the design, these other supplies can be pulled up also.

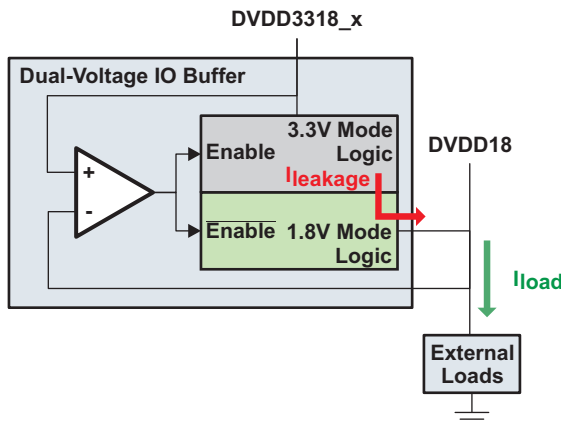
Figure 8. Error State of the IO buffer during Zone G

As DVDD3318\_x exceeds DVDD18+V<sub>T</sub>, some of the circuitry across the boundary of the two voltage domains will turn on and causes a leakage current (in red) to flow between the two voltage domains. This current pulls up the DVDD18 supply unless the power source providing that supply can oppose it or unless the load current is strong enough to counteract it.

If DVDD18 continues to rise as DVDD3318\_x ramps, the comparator never sees enough difference between the two supplies to switch to 3.3V mode.

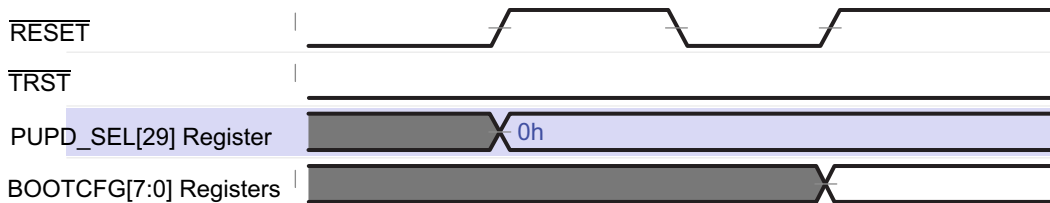
**Figure 10. Initialization of PUPD\_SEL[29] and BOOTCFG[7:0] Registers with Weak or No External Pull Resistors on BOOT[7:0] Pins**

Internal pullups being enabled on the BOOT[7:0] pins may result in boot failures. If weak external pulldown resistors are used on the PCB to select the boot mode, they may not be able to overpower the internal pullups. This can result in the wrong boot mode being latched in the BOOTCFG[7:0] register when coming out of Reset.

Once the device is out of Reset, the PUPD\_SEL[29] register is initialized, and the internal pulldown resistors for the BOOT[7:0] pins are all enabled. Issuing a second Power-On Reset ( $\overline{POR}$ ) results in the intended boot mode being latched, since the pins are internally pulled down as expected.

Figure 10 shows the behavior of the PUPD\_SEL[29] register before and after reset. Assuming weak or no external pull resistors are on the BOOT[7:0] pins, the BOOTCFG register will latch the unknown values after the device initially comes out of Reset. Note that, TRST **must** always be low in order to issue a POR and latch the boot pin values -- the boot pins are not latched after a Warm Reset.

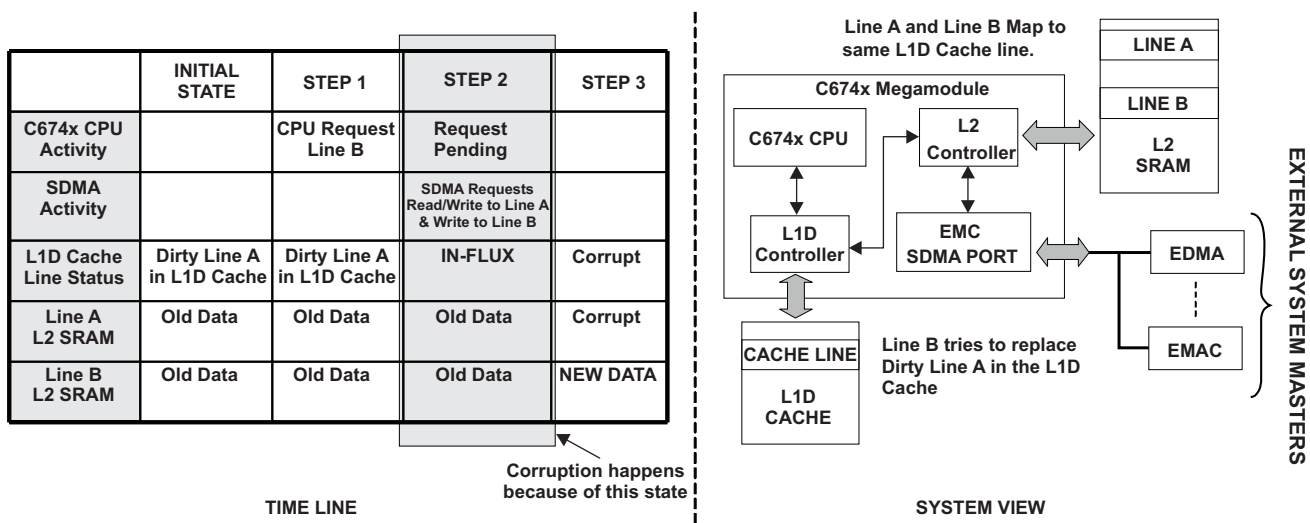
**Figure 11. Example of L1D Cache and L2 RAM Corruption**

An L1D cache-line corruption event occurs when all of the following conditions are met:

1. L1D cache evicts a dirty line (Line A) while allocating a new line (Line B) in the same set/way (cache Lines A and B consist of 64-bytes each). In order for this to happen, the following will have taken place:
  - (a) Line A was previously read by CPU because L1D is a read-allocate cache,
  - (b) Line A is dirty because its value was modified by CPU, and
  - (c) Line B is read by CPU
2. Both Line A and Line B are associated with L2 RAM, and
3. While the original L1D victim write-back from condition (1) is in progress, the SDMA performs both:
  - (a) a read or write operation to Line A in L2 RAM and
  - (b) a write operation to Line B in L2 RAM.

If all of the above conditions are met, the L2 RAM data associated with the Line A victim writeback will become corrupt. Additionally, the Line B data originating from the SDMA write will also become corrupt in L1D cache. [Figure 11](#) shows an example scenario of L1D cache and L2 RAM corruption.

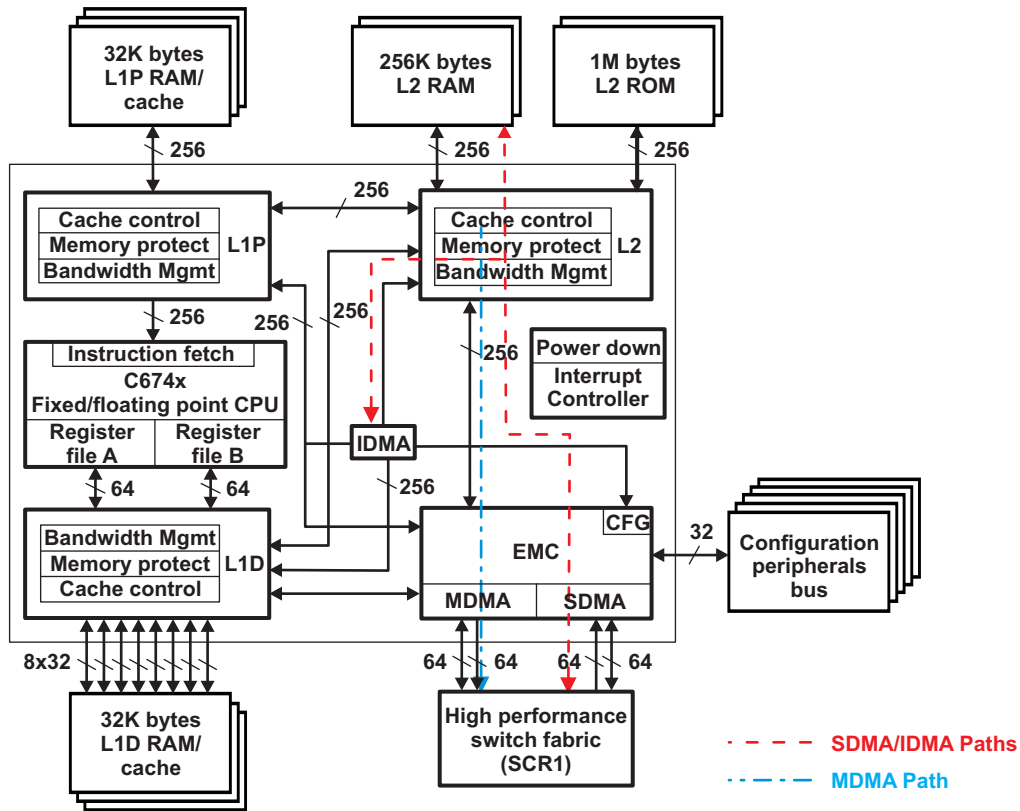
Figure 12. C674x Megamodule

Ideally, the MDMA (dashed-dotted line in Figure 12) and SDMA/IDMA paths (dashed lines in Figure 12) operate independently with minimal interference. Normally MDMA accesses may stall for extended periods of time due to expected system level delays (e.g., bandwidth limitations). However, when using L2 as RAM, SDMA and IDMA accesses to L2/L1 may experience unexpected stalling in addition to the normal stalls seen by the MDMA interface. For latency-sensitive traffic, the SDMA stall can result in missing real-time deadlines. In a more severe case, the SDMA stall can produce a deadlock condition in the device. An IDMA stall cannot produce a deadlock condition.

**Note:** SDMA/IDMA accesses to L1P/D will not experience an unexpected stall if there are no SDMA/IDMA accesses to L2. Unexpected SDMA/IDMA stalls to L1 happen only when they are pipelined behind L2 accesses. Additionally, the deadlock scenario will be avoided if there are no SDMA accesses to L2.

1. Configure the entire L2 RAM as 100% cache (e.g., move all data buffers from L2 to L1D or other memory). Note: Some throughput degradation is expected when the buffers are moved out to external memo
2. Eliminate all IDMA/SDMA access to L2 RAM when IDMA/SDMA stalling would have an impact by performing one of the following:
  - (a) Constrain each DMA master group to perform writes to either DSP memory space or external memory space, but not to both, or
  - (b) Force each DMA master group to complete pending write commands to either DSP memory space or cacheable memory space before initiating writes to a different destination. Pending write commands from DMA masters are forced to complete when the DMA master initiates a read from the same destination memory. Note that in the case of off-chip memory, a read command only forces the completion of write commands within a 2KB-aligned window.

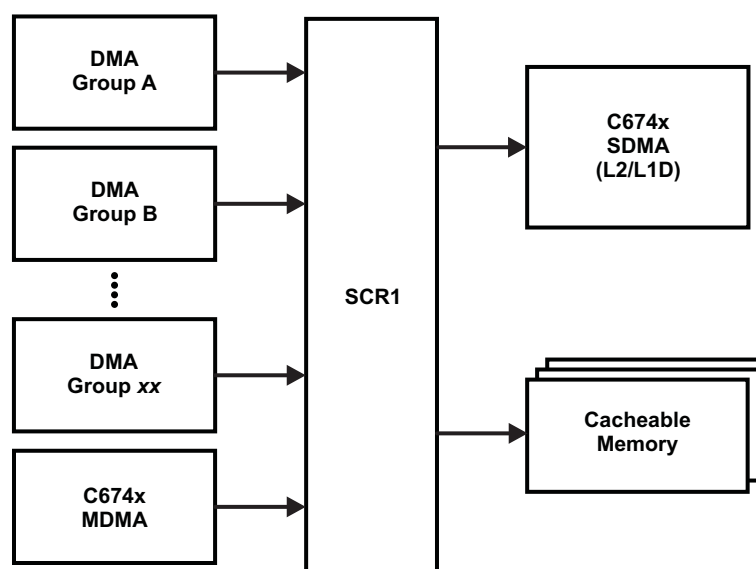
**Figure 13. SCR1 System Interconnect**

Step 2: The DSP's SDMA asserts itself as not ready and is unable to accept the write data from Step 1, and a cache line writeback is initiated from DSP memory to the same cacheable memory from Step 1. The cache line writeback command also passes through SCR1.

With the above scenario, it is possible for SCR1 to order the write commands from Step 1 in front of the write commands from Step 2. Due to the MDMA/SDMA blocking behavior, the SDMA commands from Step 2 will be waiting for the MDMA traffic from Step 1 to finish, resulting in a deadlock situation at SCR1. [Figure 13](#) is provided for illustrative purposes and is incomplete because of simplification.

Entirely eliminate IDMA/SDMA stalling and potential for a deadlock condition using one of the following two methods:
