# **TMS320C6748 Fixed/Floating-Point DSP Silicon Revisions 2.1, 2.0, 1.1 and 1.0**

## **Silicon Errata**

Literature Number: SPRZ303F  
June 2009–Revised April 2012

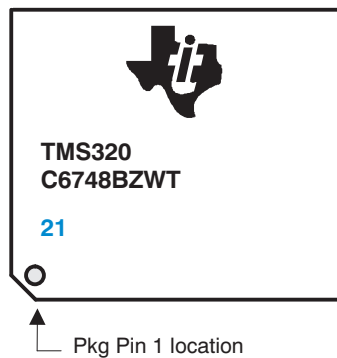
**Figure 1. Device Markings**

DEVICE REVISION CODE (xx)	SILICON REVISION	COMMENTS
B	2.1	Silicon Revision 2.1 can be differentiated from Revision 2.0 by a top side '21' marking on the package. See <a href="#">Figure 1</a> for details. Additionally the ROM ID code may be used to distinguish Revision 2.1 from Revision 2.0
B	2.0	-
A	1.1	-
(blank)	1.0	-

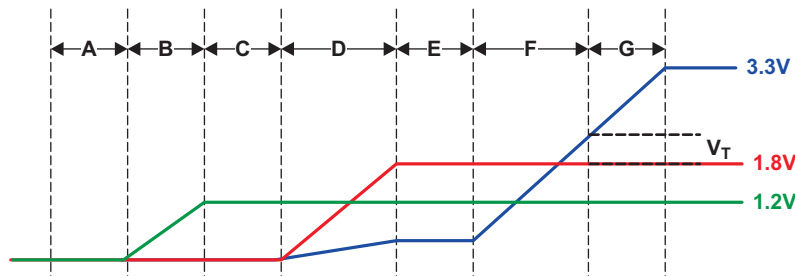
**Figure 5. Normal power-supply ramp**

- A. All device supplies are undriven
- B. The 1.2V supplies are ramped to their nominal levels
- C. Potential delay between supply ramps (not required)
- D. The 1.8V supplies (specifically DVDD18) are ramped to their nominal levels. During the DVDD18 ramp there will be some minor drift up in the undriven DVDD3318\_x supplies. This is normal and is not a problem.
- E. Potential delay between supply ramps (not required)
- F. DVDD3318\_x is ramping but is less than DVDD18 + V<sub>T</sub>
- G. DVDD3318\_x is ramping but is greater than DVDD18 + V<sub>T</sub>

**Important Note:** The 3.3V DVDD3318\_x supplies must not be driven to 0V during zones A – E or high current capable of damaging the device may occur. The 3.3V DVDD3318\_x supplies should not be driven during this time.

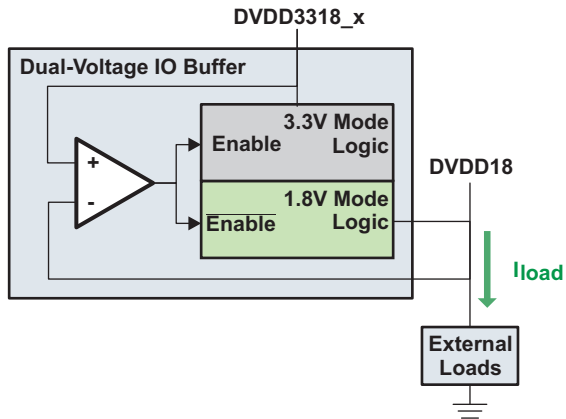
**Behavior of the IO buffer during Zone F:**

The condition occurs because the dual-voltage IO buffers have voltage detection circuitry that monitors DVDD3318\_x during reset and determines whether the applied supply voltage is 1.8V or 3.3V. This detection circuitry then configures the IOs to operate at the appropriate voltage. As the DVDD3318\_x supply ramps, there is a small range near DVDD18 + V<sub>T</sub> where the voltage detection circuit finds the state indeterminate and briefly turns on circuitry associated with both voltage options creating a current path between them. This current path can cause the DVDD18 supply to be pulled up. The mechanism for this behavior is explained below:

As the DVDD3318\_x supply ramps, but is not yet one V<sub>T</sub> above the DVDD18 supply, the comparator enables the 1.8V mode logic section and disables the 3.3V mode logic section. No unexpected current flows between the two sections.

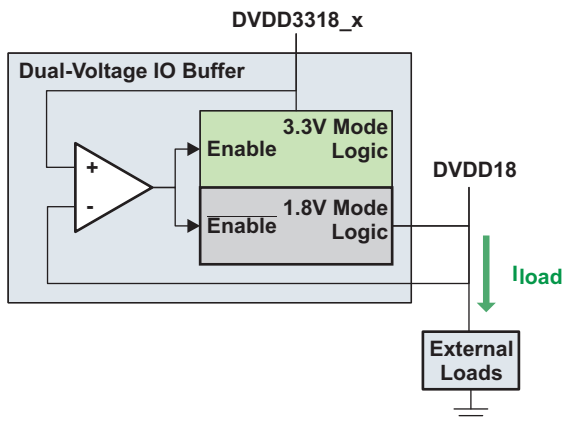
**Recovered State of the IO buffer during Zone G:**

If the load current is high enough or the DVDD18 power supply can oppose the leakage current, then the DVDD18 voltage stays low enough for:
